Manhole Inspection Summary

Manhole # S13EE2007MH

Insp Date: **10/24/06 1:11 PM**

Location Address: **2132 BONNIE VIEW DR**

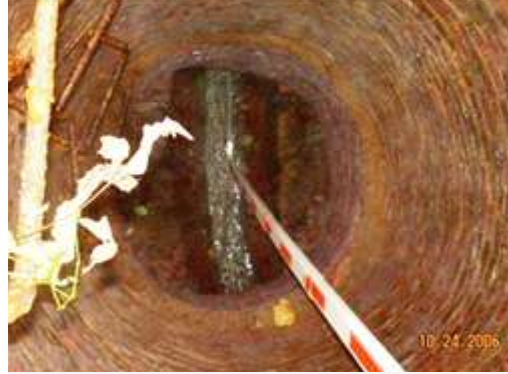
Top View

Steps Count: **12** Missing: **0** ☒ **Corroded**

Corroded steps.

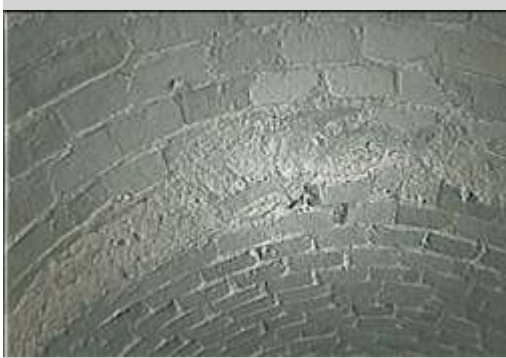
Defect

Condition: ☐ Sound ☐ Cracked ☐ Root Intrusion ☐ Loose Brick ☒ **Deteriorated**

Infiltration: ☐ None ☐ Joint ☐ Cracks ☒ **Mortar** ☐ Roots ☒ **Wall**

Corbel and Barrel deterioration and infiltration.

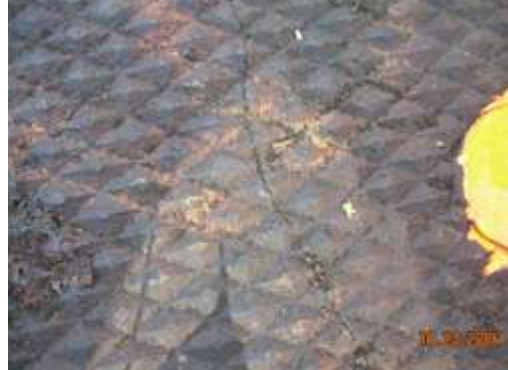
Defect

Type: **Sanitary** Condition: **Cracked** Cover Material: **Cast Iron**

Cracked lid.

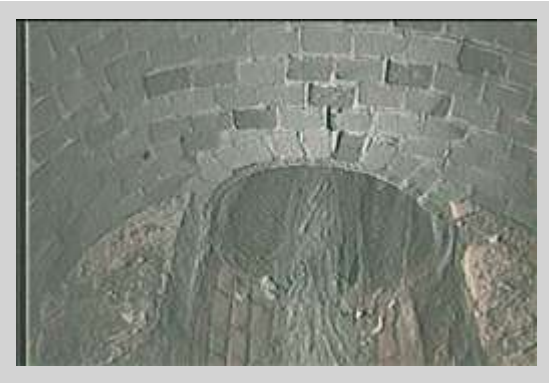
21 in. Circular Gravity Sewer Pipe Out @ 12 O'Clock

Deposits: ☐ None ☐ Mud ☐ Sludge ☐ Debris ☒ Grease

Silt Depth: **0** (in.) Deposits Extent: **Light**

Infiltration: **Evidence** Pipe Seal Cond: **Unknown**
